A Source of Peace - Transboundary Water Management in Central Asia

Rehabilitation of the 'Zumratsho' headwork in Isfara, Tajikistan

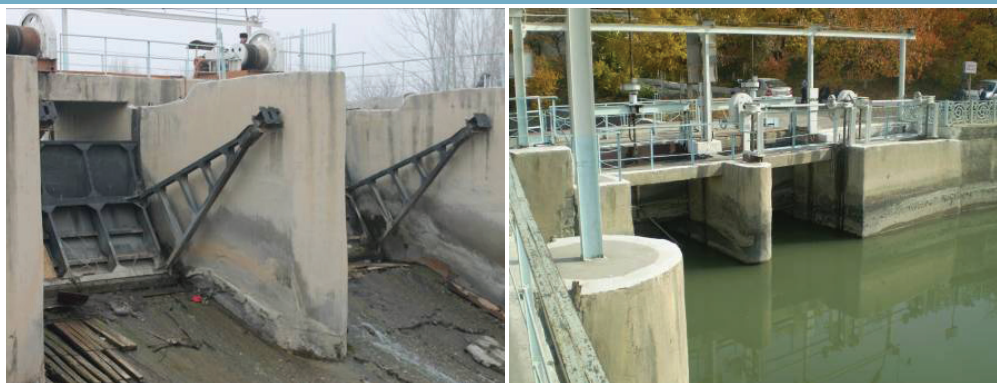
L. to r.:

Seasonal floods and mudslides filled the headwork structure with soil, stones and gravel, destroying its concrete base and gates. This resulted in a decrease in the headwork's water intake. Consequently, the amount of water available for irrigation and drinking has gradually fallen. Recently, the headwork's technical condition was rated as critical. A number of structures were not operational. The lower spillway dam, the concrete lining of the upper and lower sections and the metal parts of the closures required immediate rehabilitation.

- 1) Segment water gates
- 2) Gates to the bypass gallery

1. Cleaning the bypass canal by installing a temporary dam
2. Rehabilitating the existing dam and water intake via the bypass canal
3. Construction measures in the lower section of the headwork
4. Cleaning and rehabilitating the water gallery for offtake of bedloads
5. Construction measures in the upper section of the headwork
6. Rehabilitating the bypass gallery
7. Rehabilitating and repairing the headwork's electrical components
